EXPEDITION OVERVIEW

LAKE KARIBA ZIMBABWE

THE
WILDERNESS
PROJECT

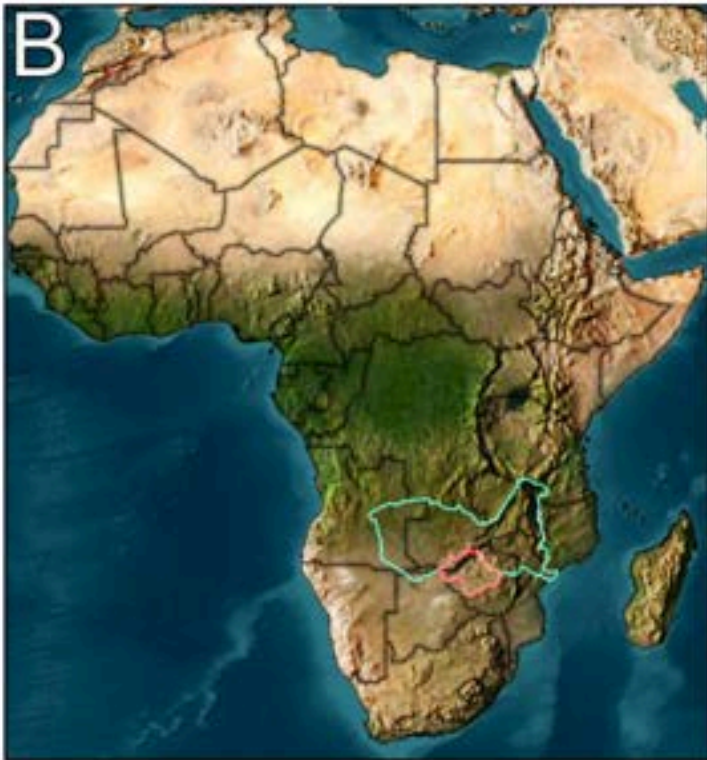
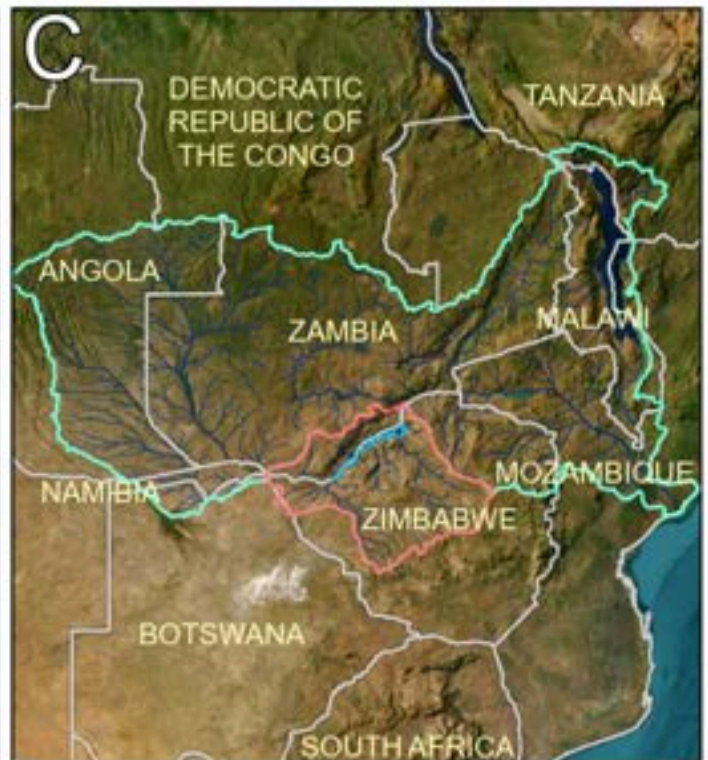
A - The 834 km track traversed by the expedition team along the south of Lake Kariba.

B - Located in the southern Africa, Lake Kariba is the largest man-made reservoir in the world

C - Situated 1 800 km upstream of the Zambezi River outflow in the Indian Ocean, Lake Kariba is critical for regional water, food and power security.

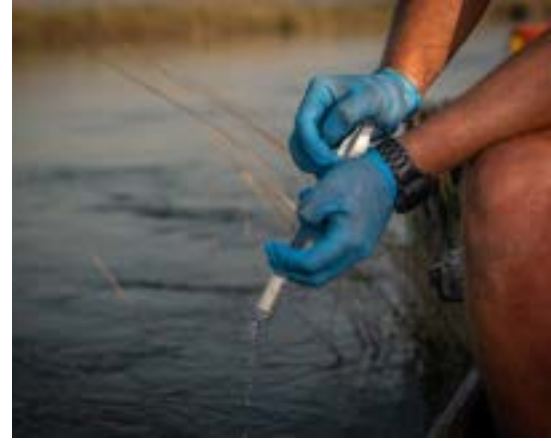
Collecting an eDNA sample

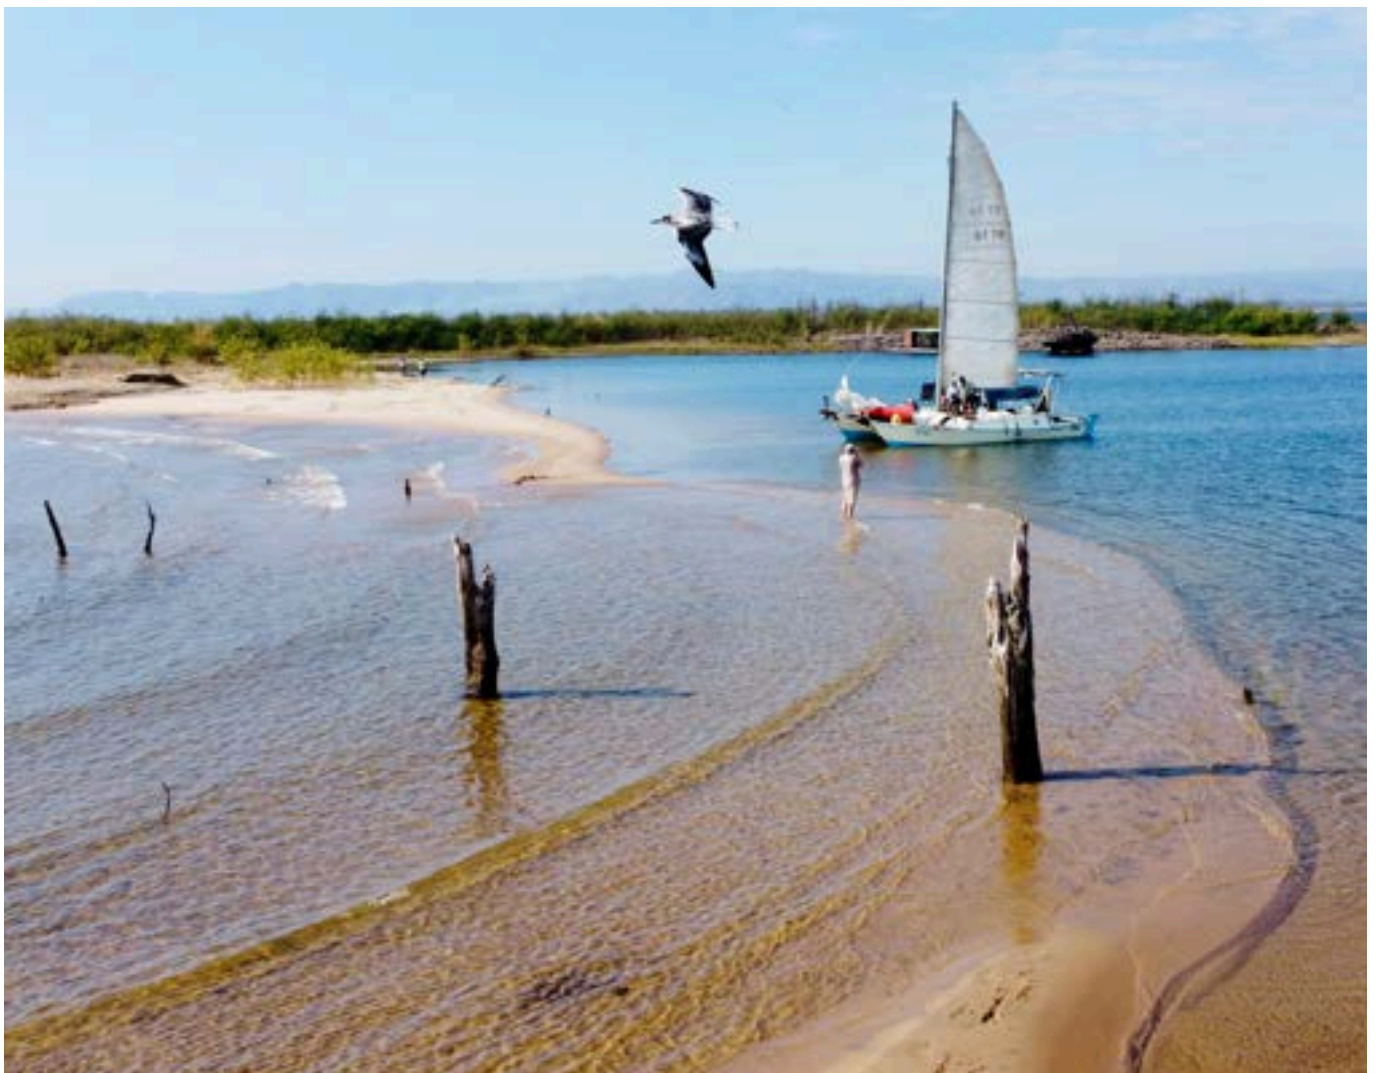
A fixed survey site at Island 155 in Lake Kariba.

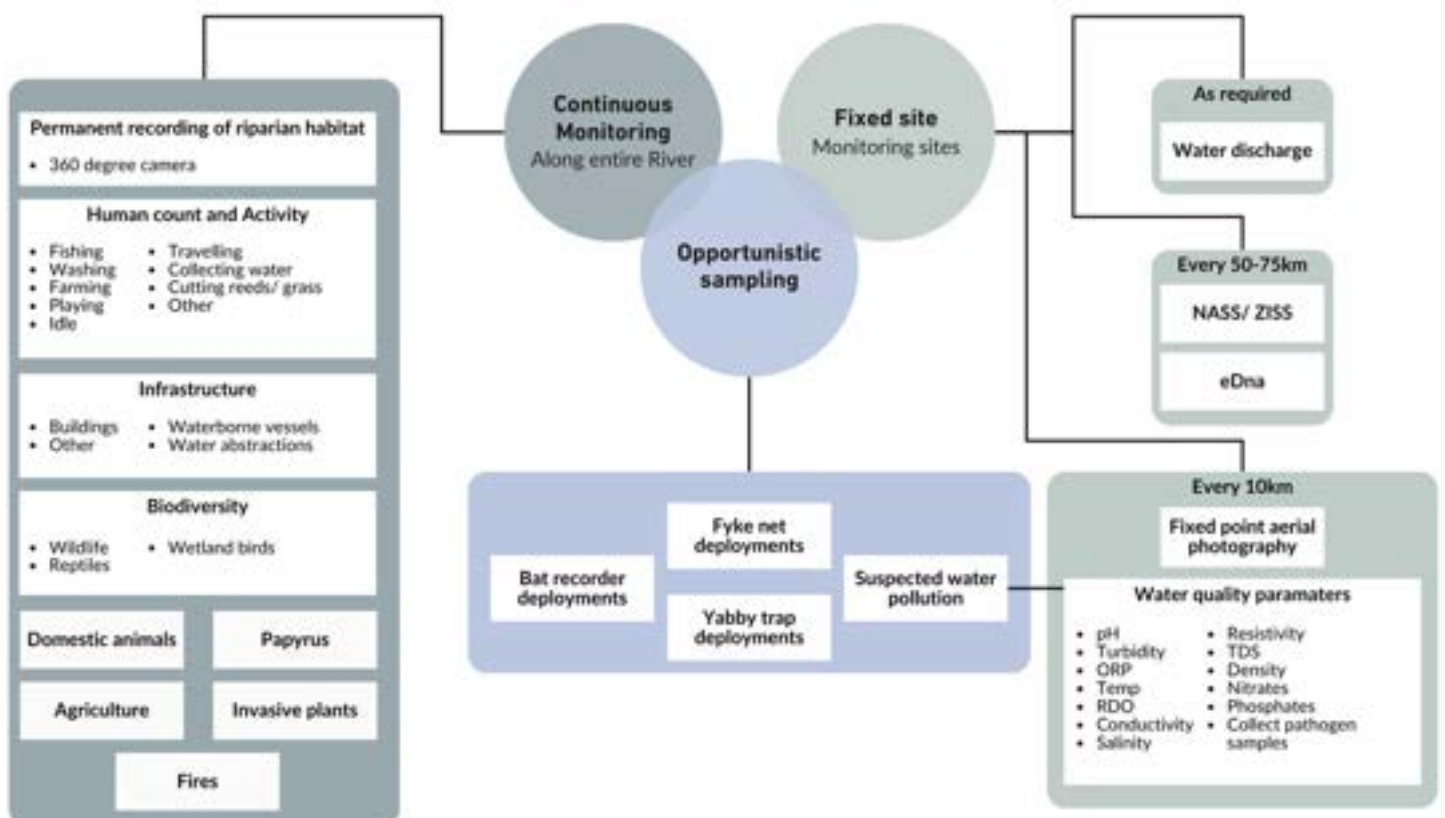
| Summary of data collected on the lake.

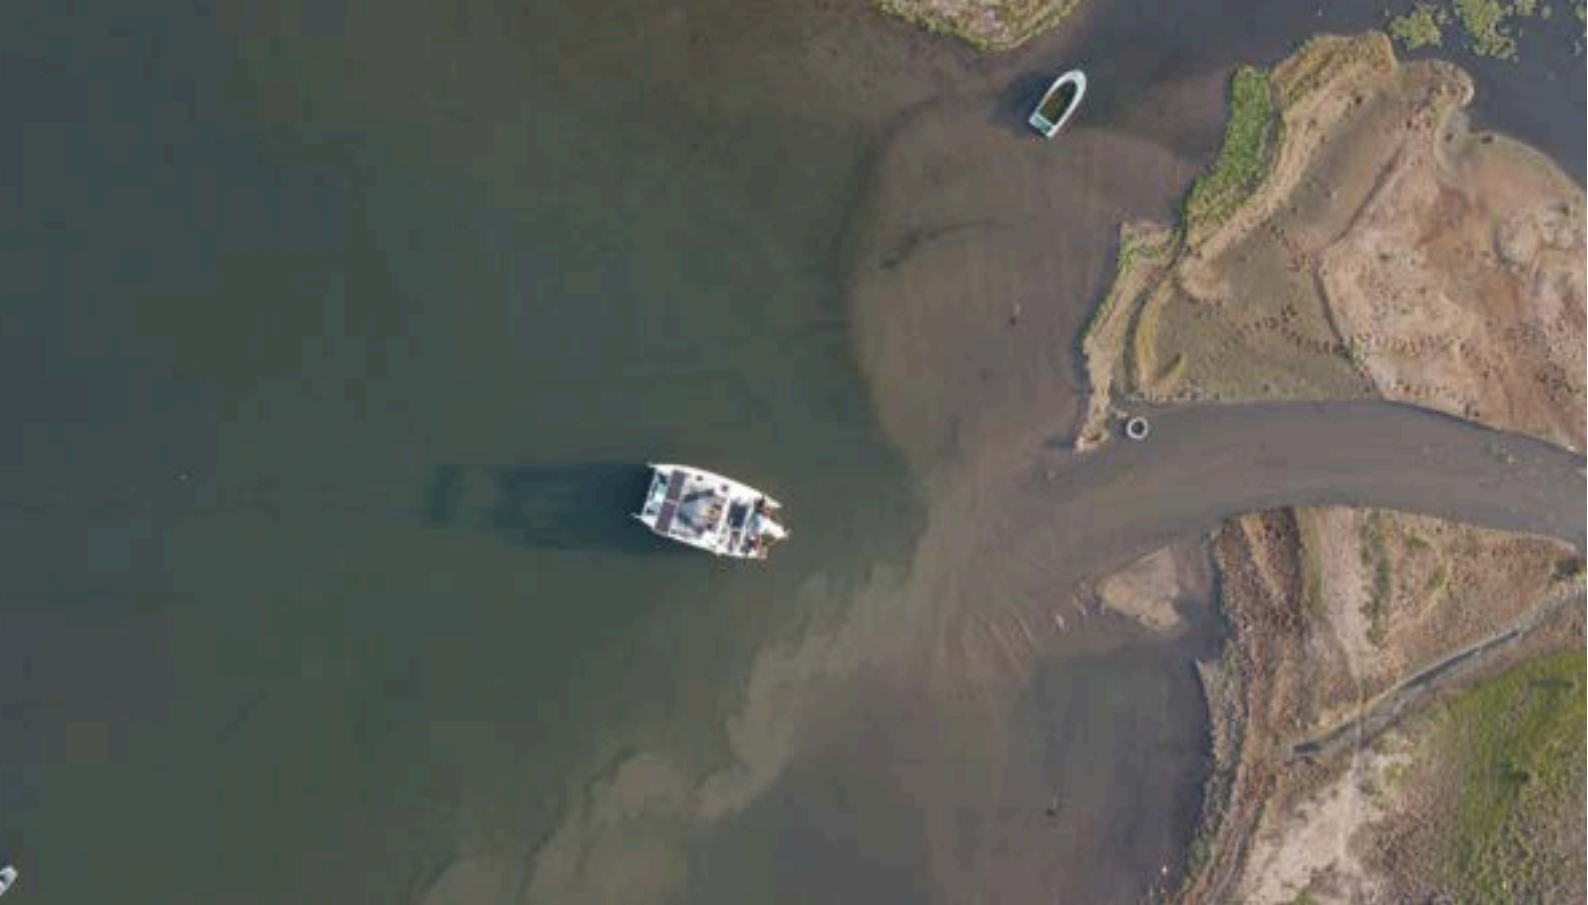
Water Quality

For the parameters measured in the field, Lake Kariba's water quality broadly aligns with the World Health Organization (WHO) guidelines for potable water¹. Exceedances of the WHO values were recorded for pH and nitrate at several points, and communities in these areas should treat their water prior to consumption. Spatial variability appears in all measured water quality parameters along the transect, likely due to: i) anthropogenic activities near and in the lake, such as aquaculture effluent, ii) modifications to lake water quality from tributaries flowing into it, and iii) daily weather fluctuations that influence the lake's physicochemical properties (e.g., water temperature).

The Deka tributary shows potential point-source pollution, likely originating from upstream mining activities. Water quality tests of the tributary, conducted above and below a mine, reveal a sharp increase in water acidity (pH of 3.6) and elevated concentrations of dissolved ions. Ongoing water quality monitoring initiatives in the lake should include a detailed assessment of the Deka's water quality.

The areas around crocodile farm effluent pipes exhibit high levels of dissolved ions, indicating possible contaminants that pose risks to the ecosystem and human health. This concern is heightened by the high density of fishers near the pipes. Further water quality testing for major ions and antibiotics around these pipes is recommended for a more comprehensive assessment.

Depth measurements reveal that water quality parameters stay consistent above 10m and only change meaningfully below 10 meters. This supports other findings that warmer climates have decreased the depth of the epilimnion² (the upper layer of water in a stratified lake) from 20 m to 10 m. This has resulted in a more stable thermocline. A more stable thermocline traps greater amounts of nutrients in the deep, cold bottom waters and reduces nutrient availability within the epilimnion. This nutrient limitation may impact aquatic life and overall water quality in the upper layers of the lake. Conducting repeated surveys will help track changes in both surface and deeper water quality over time.

- Conduct ongoing water quality monitoring at several fixed survey sites along the Lake Kariba transect, including the Deka Tributary and aquaculture farm effluent pipes. Include depth measurements to track changes in the thermocline, as these can impact nutrient availability and overall water quality.

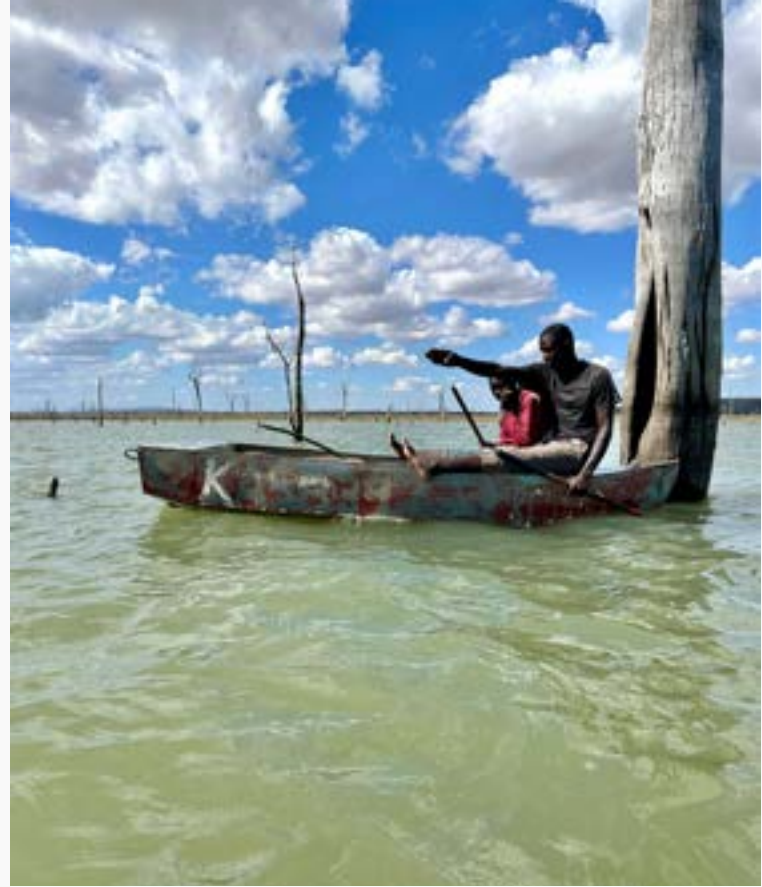
Fishermen on Lake Kariba

People are present along most stretches of Lake Kariba, with activity concentrated around the towns of Binga, Chibuyu, Chalala, and Kariba. Satellite analysis shows that the Zimbabwean side of the lake has half the number of buildings (5.10 buildings per km²) compared to the Zambian side (10.82 buildings per km²). Fishing serves as the primary livelihood on Lake Kariba, encompassing both the Kapenta industry and artisanal fishing.

Fishing activity on Lake Kariba remains high, except within designated National Parks and Safari areas. Kapenta fishing dominates the industry, with 342 Kapenta boats counted during the transect. However, Kapenta catch volumes have declined from a peak of 20,000 tonnes in 1990 to roughly 6,000 tonnes in 2020 due to overfishing, climate change, and reduced lake levels³. Additionally, 396 individuals were observed engaging in artisanal inshore fishing, mainly using gill nets. Numerous illegal fishing camps and boats were also noted along the transect. ZimParks conducts regular patrols along the lake, playing a key role in addressing illegal fishing by removing gillnets and actively curbing this issue. Increased and continued support of ZimParks is recommended to increase their capacity to manage illegal fishing on Lake Kariba.

- Conduct a detailed fisheries assessment of Lake Kariba to reassess the sustainability of fishing techniques and fishing pressure within the system.
- Develop and implement targeted control programs for the red claw crayfish. This includes promoting overexploitation of the crayfish as an alternative protein source, thereby reducing fishing pressure on native fish populations. This approach, as suggested by the University of Zimbabwe, could help control the crayfish while supporting sustainable protein sources for local communities.
