## MDTP - SADC/GIZ Project

#### Cross Border Climate Change Adaptation

#### ***Project Title: Implementing wetland rehabilitation to respond to drought in the Maloti Drakensberg Transfrontier Focus Area`***

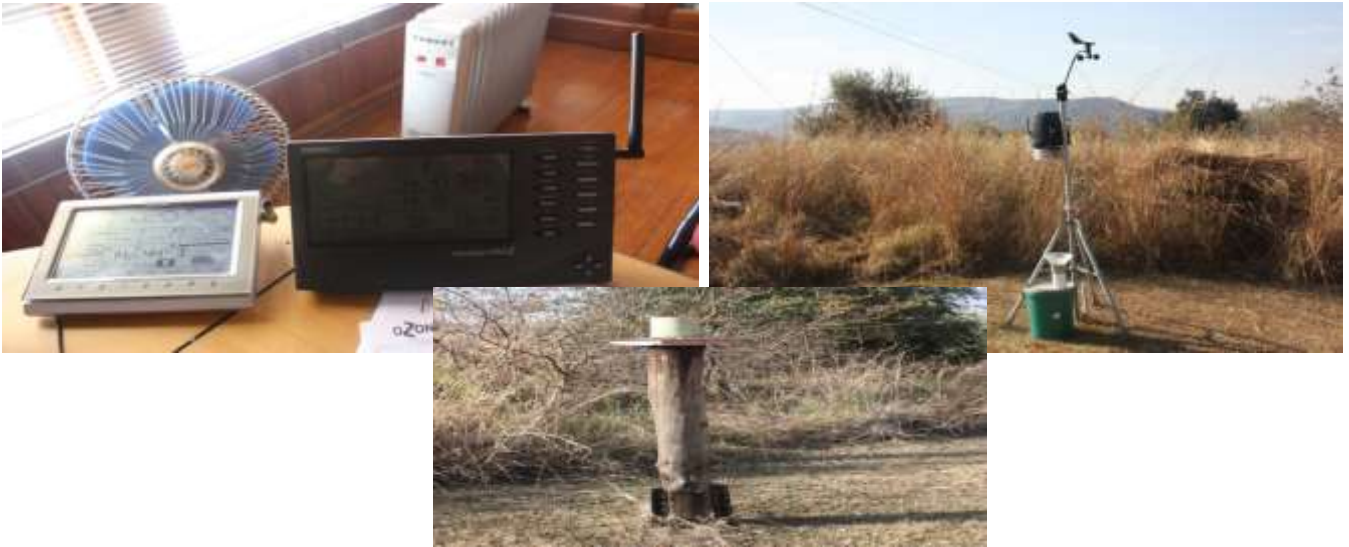
**Figure 1:** Shows equipment implemented at Cathedral Peak Didima to monitor climate variations – temperature, windspeed, rain, humidity. Data from the equipment is downloaded, stored for analysis of climate variations over time.

It is important to also note that one of the objectives of this project is to contribute to climate change adaptation and mitigation. Observed at Cathedral Peak were equipment used to monitor climate variations as shown in figure 1 above.

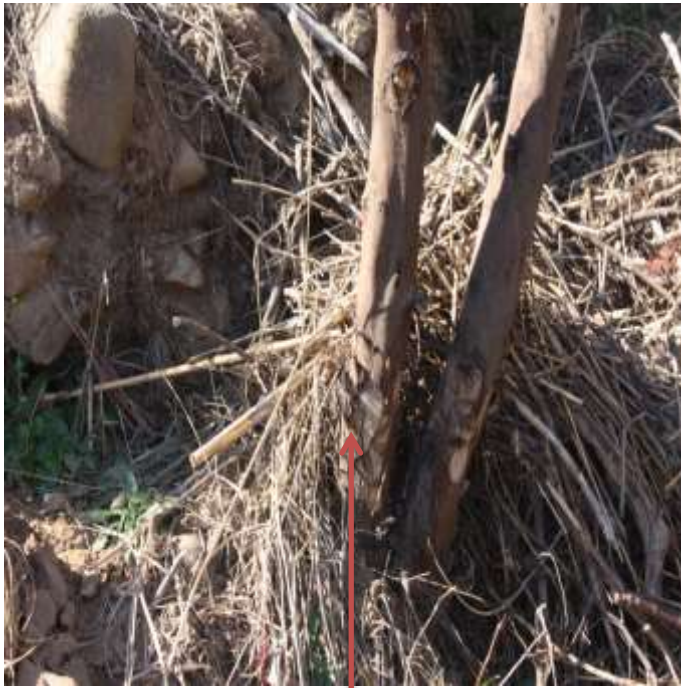
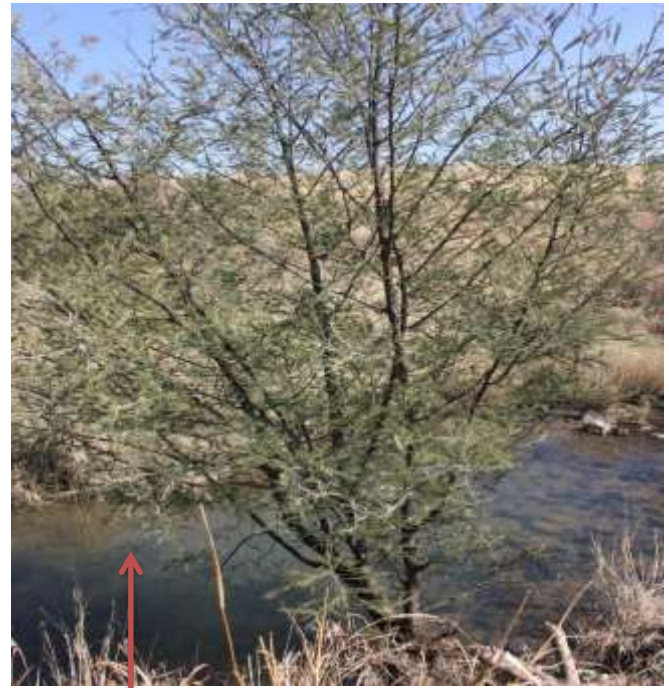
**Historical clearing – ringbarking used to discourage growth**

**A flowing stream infested by wattle And other IAPs**

**Figure 3:** *Depicts historical clearing in the wetland that need to be addressed*

As shown in the figure above, there has been clearing of IAPs done in the wetland area. Ring-barking was used to kill IAPs while standing. The work in the area was not completed and even some of the trees ringbarked were not done properly. There has not been any use of herbicides which makes sense given that the area is a wetland area, however further consultation will be done to acquire advice on the best method to use, and the best herbicide that can be applied.

The main activity that will be implemented to address issues in the wetland area is the clearing of IAPs. As mentioned above the dominant species that will be cleared in the wattle. There are also reeds which are not necessarily IAPs that may be removed in smaller dams used for recreation as they become a nuisance. The reeds will be removed to improve water flow. The clearing method that will be range from:

Advice is still required with regards to the best method and the consideration of use of herbicides in wetland areas. The aim is to ensure that if the cut and slash method is used, the aboveground bioamss is not left along the stream, but debranched, logged, stacked and pulled out of the clearing area. This is aimed at ensuring that the aboveground bioamss is not washed down to the straems during rains, or contributes to the increase in the intensity of the fires if the area is burnt in the near future. The wood will be accessible to communities for energy provision. This is propobaly on of the benefits of the project to the community.

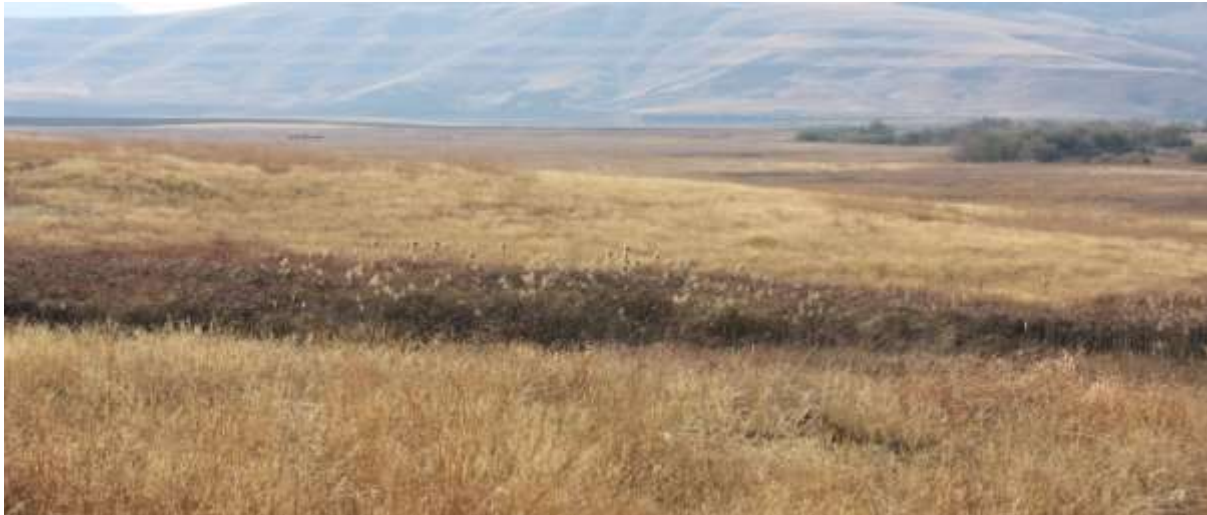
There is also evidence of bird nests in the area as shown in the figure below. According to staff at Culfargie Bald ibis and Crowned cranes has also been spotted in the area.

**Figure 4:** Showing bird nests in the wetland area.

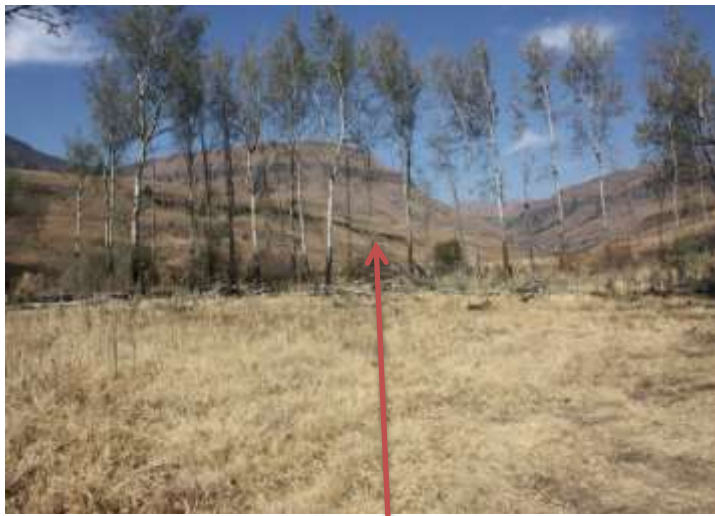
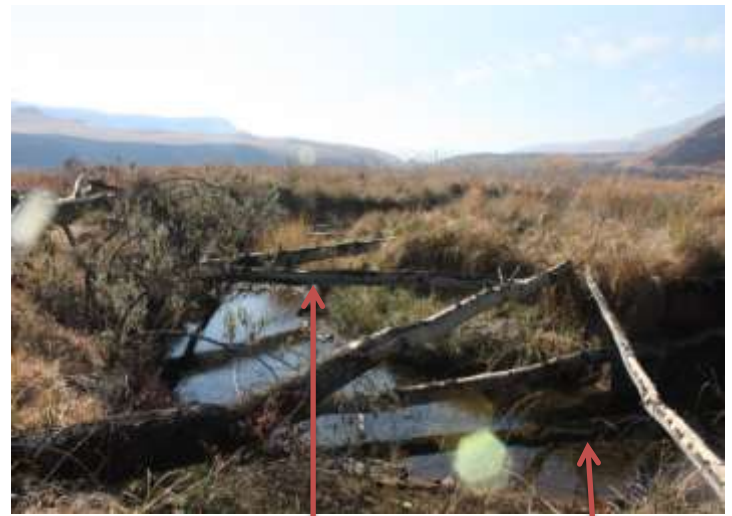
**Poplar species**

**Clearing of IAPs**

**Mzonjwana River**

**Figure 5:** *Depicts historical clearing and also the dominant IAPs in the wetland that need to be addressed*

The park management recognised the need to implement a rehabilitation programme in the wetland area in order to revive its functioning. There has been clearing of IAP as shown in figure 5 above since August 2013. Three chainsaw operators and one general assistant have worked in the area conducting IAP clearing. The aboveground biomass has not been removed yet. This will be done as soon as the team has been relieved from the fire operations.

The main activity that will be implemented to address issues in the wetland area is the clearing of IAPs. As mentioned above the dominant species that will be cleared is the poplar. The clearing method that will be range from:

Advice is still required with regards to the best method and the consideration of use of herbicides in wetland areas. The aim is to ensure that if the cut and slash method is used, the aboveground biomass is not left along the stream, but debranched, logged, stacked and pulled out of the clearing area. This is aimed at ensuring that the aboveground biomass is not washed down to the streams during rains, or contributes to the increase in the intensity of the fires if the area is burnt in the near future. The wood will be accessible to communities for energy provision if required, otherwise it will be stacked and burnt.

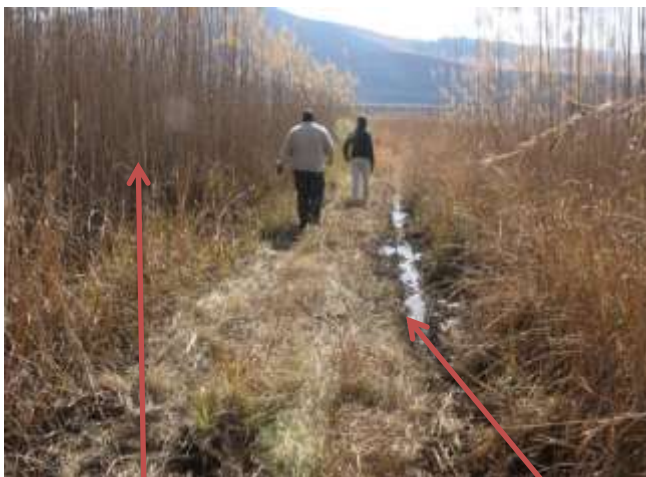
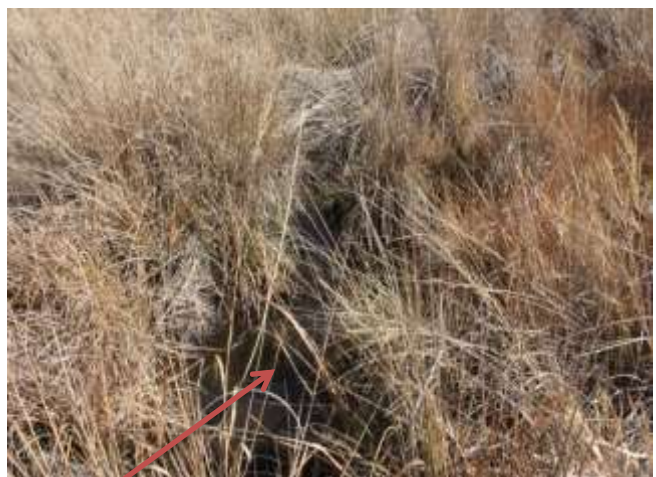
**Wetland vegetation**

**Water logged areas**

**Figure 6:** *Depicts the conditions surrounding the wetland that need to be addressed*

Although the wetland is degraded, there are areas still remaining which are still functioning as water retaining areas especially areas at the bottom of the wetlands where there are no IAP and areas not accessible to the public visiting the picnic area.
